## SUMMARY

1712 Marbury Ln, Albany GA 31707

April 4, 2018

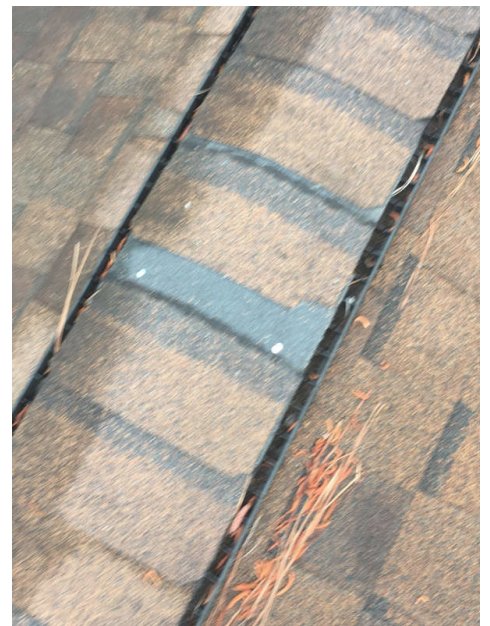
### 2.1.2 Coverings

#### **SHINGLES MISSING**

Observed areas that appeared to be missing sufficient coverings. Recommend qualified roofing contractor evaluate & repair.

Contact a qualified roofing professional.

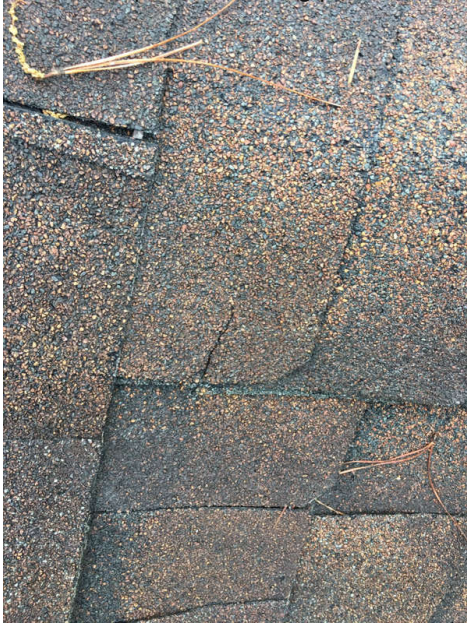
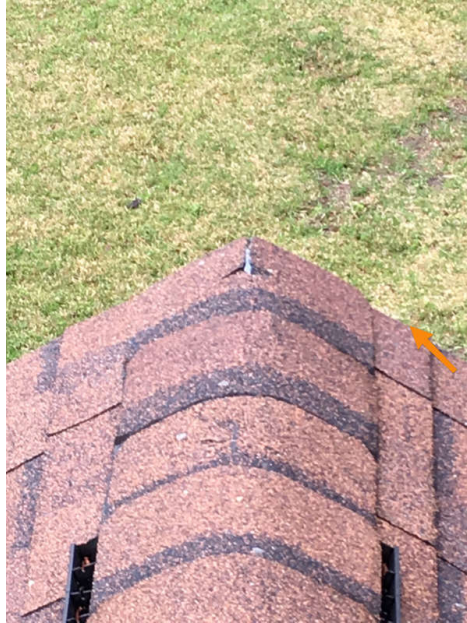
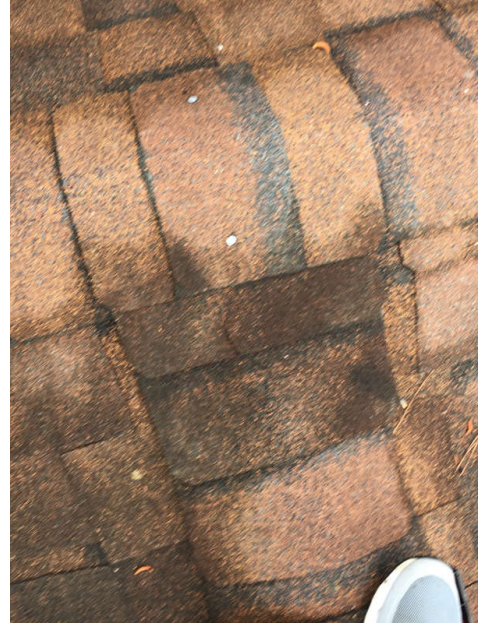
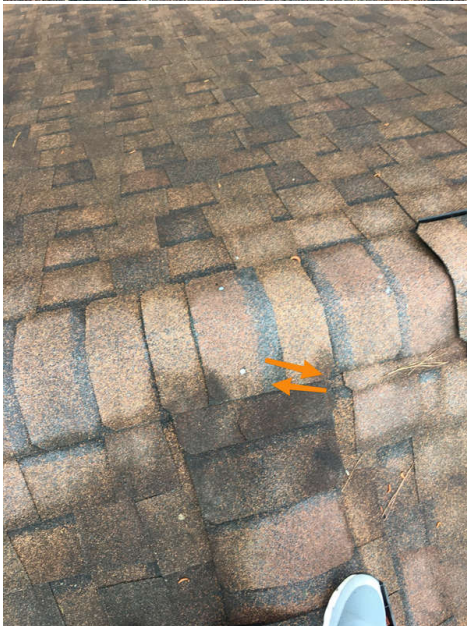
### 2.1.3 Coverings

#### **SPLITTING**

The asphalt composition shingle roof had torn or split shingles which could lead to moisture intrusion. Recommend a qualified roofing contractor repair.

Contact a qualified roofing professional.

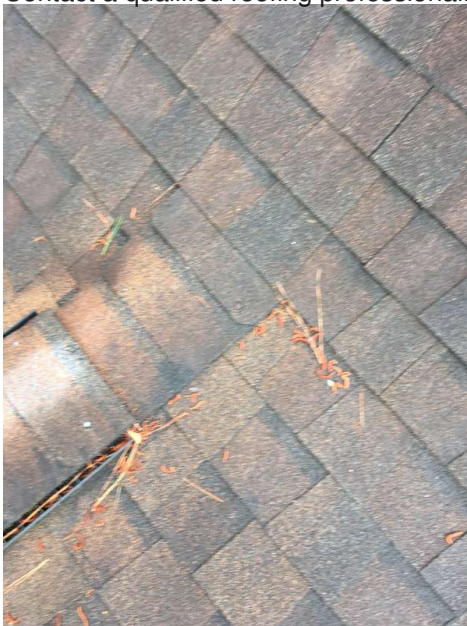
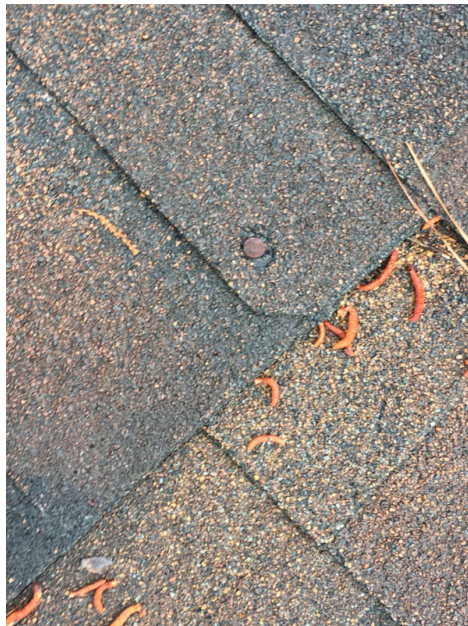
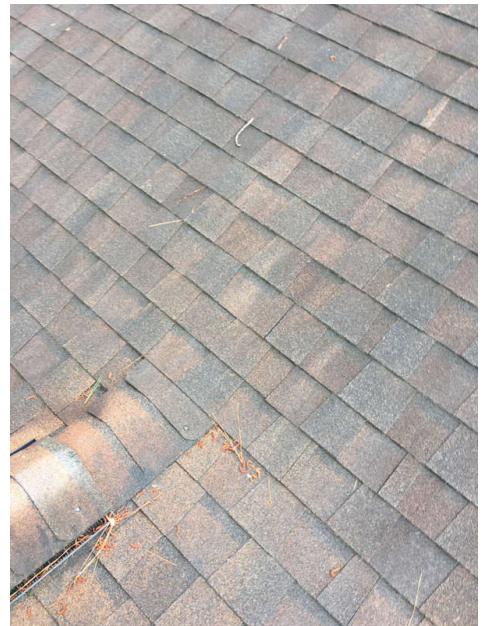
#### 2.1.5 Coverings

### **UNDER-DRIVEN NAILS OR NOT ANY CAULK**

Observed one or more under-driven nails/fasteners. Recommend a qualified roofing contractor evaluate and repair.

Contact a qualified roofing professional.

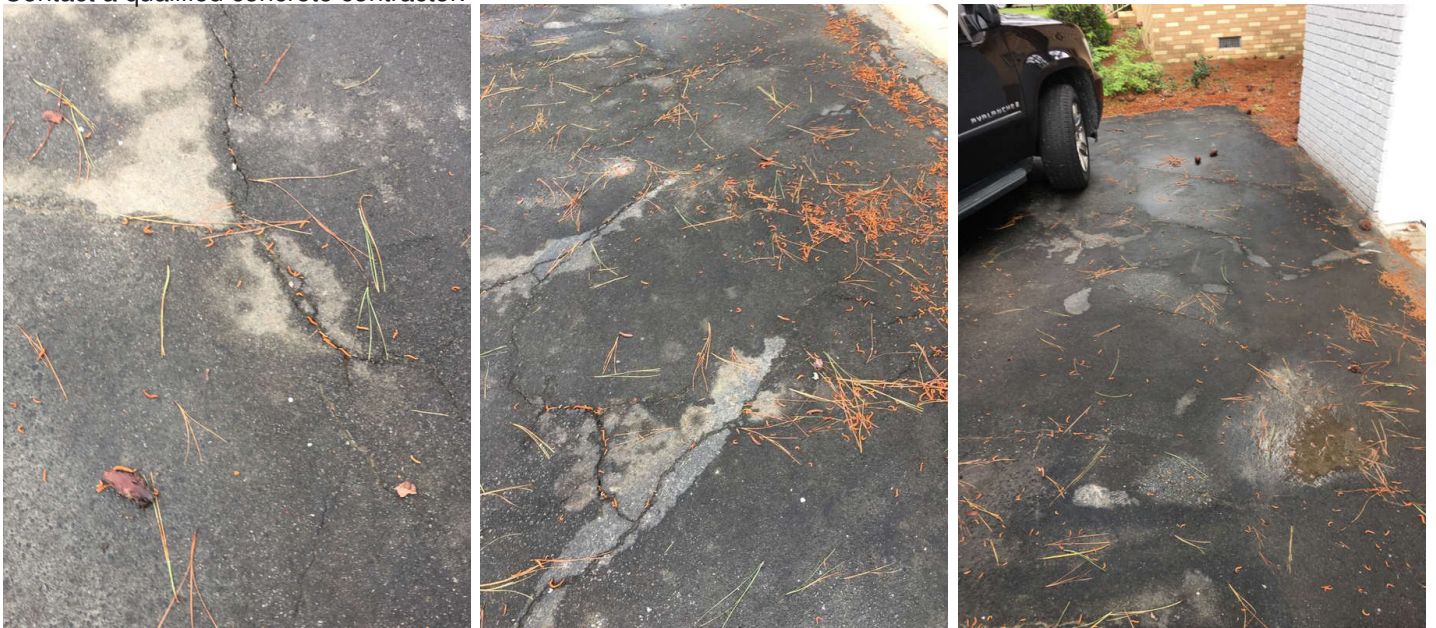
3.3.1 Walkways, Patios & Driveways  
**DRIVEWAY CRACKING - MINOR**

Minor cosmetic cracks observed, which may indicate movement in the soil. Recommend monitor and/or have concretecontractor patch/seal.

Recommendation  
Contact a qualified concrete contractor.

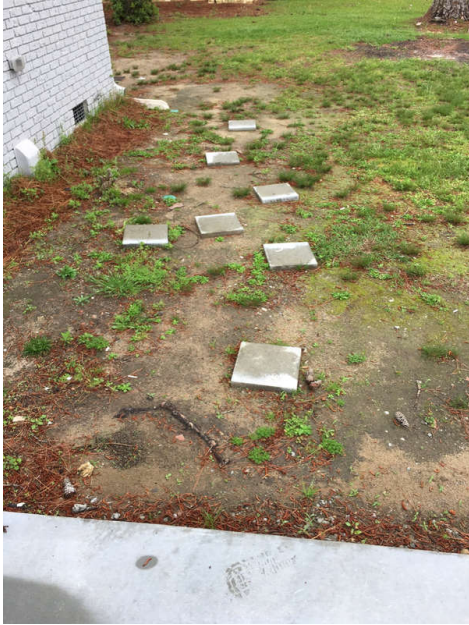
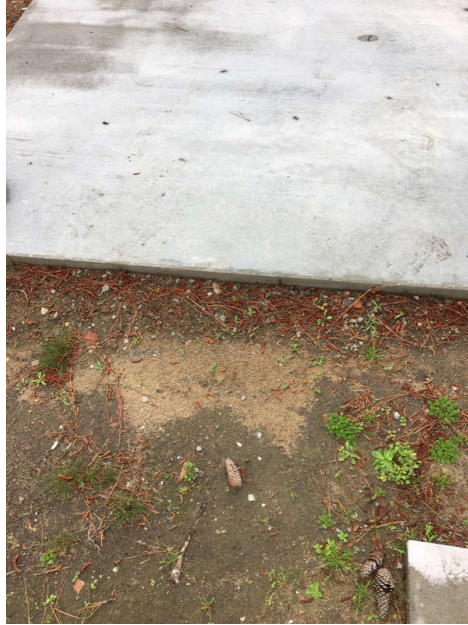
3.3.2 Walkways, Patios & Driveways  
**DRIVEWAY TRIP HAZARD**

Trip hazards observed. Patch or repair recommended.

Recommendation  
Recommended DIY Project

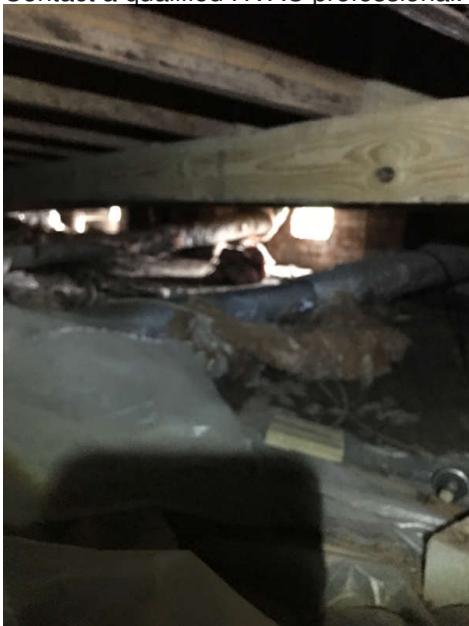
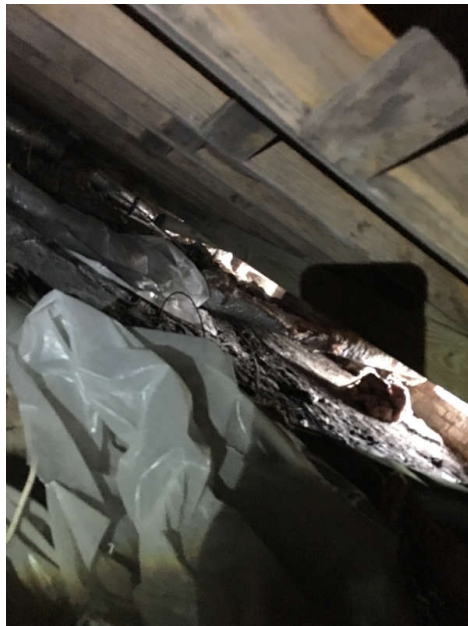
#### 5.3.1 Distribution Systems

### **DUCTS NOT SEALED**

Air supply ducts were not properly sealed. Recommend a qualified HVAC contractor seal supply and return ducts for maximum efficiency.

Recommendation  
Contact a qualified HVAC professional.

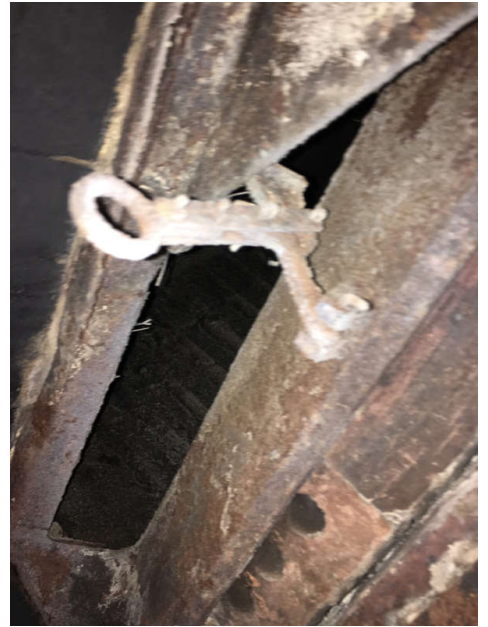
#### 5.4.1 Vents, Flues & Chimneys

### **DAMPER INOP**

Have a qualified handy man to repair

Recommendation  
Contact a qualified professional.

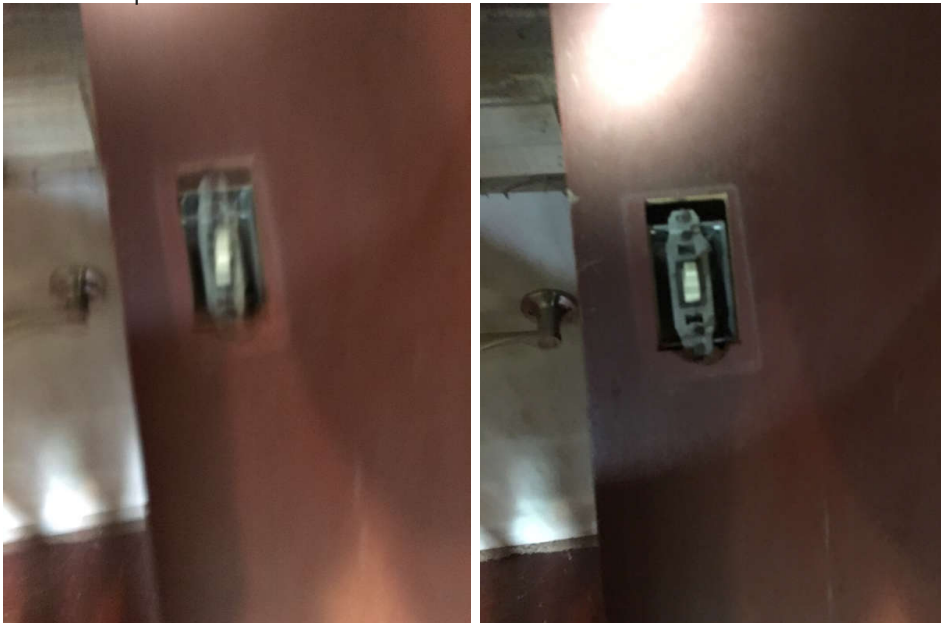
#### 8.4.1 Lighting Fixtures, Switches & Receptacles

##### **COVER PLATES MISSING**

One or more receptacles are missing a cover plate. This causes short and shock risk. Recommend installation of plates.

Contact a qualified electrical contractor.

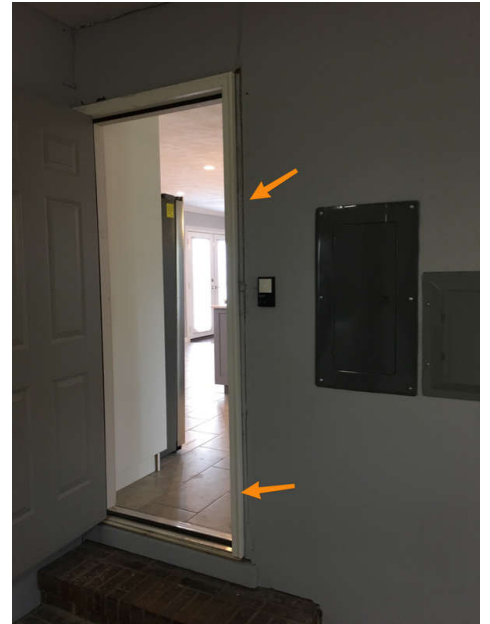
#### 10.1.1 Doors

##### **MISSING TRIM**

Have a handyman replace trim.

Contact a qualified professional.

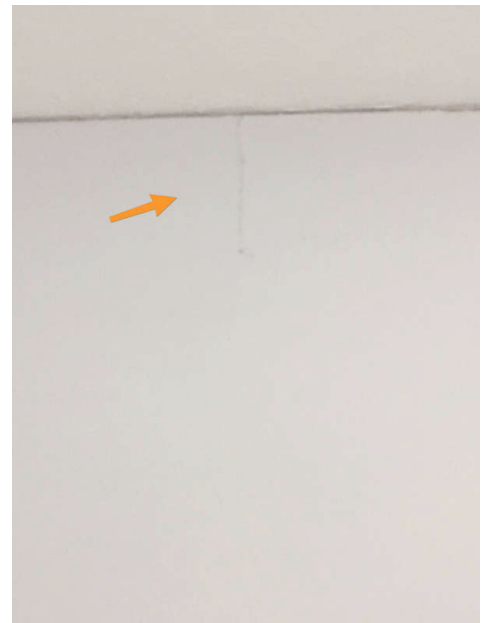
#### 10.4.1 Walls

### **MINOR CORNER CRACKS**

Minor cracks at the corners of doors and windows in walls. Appeared to be the result of long-term settling. Some settling is not unusual in a home of this age and these cracks are not a structural concern.

Contact a qualified professional.

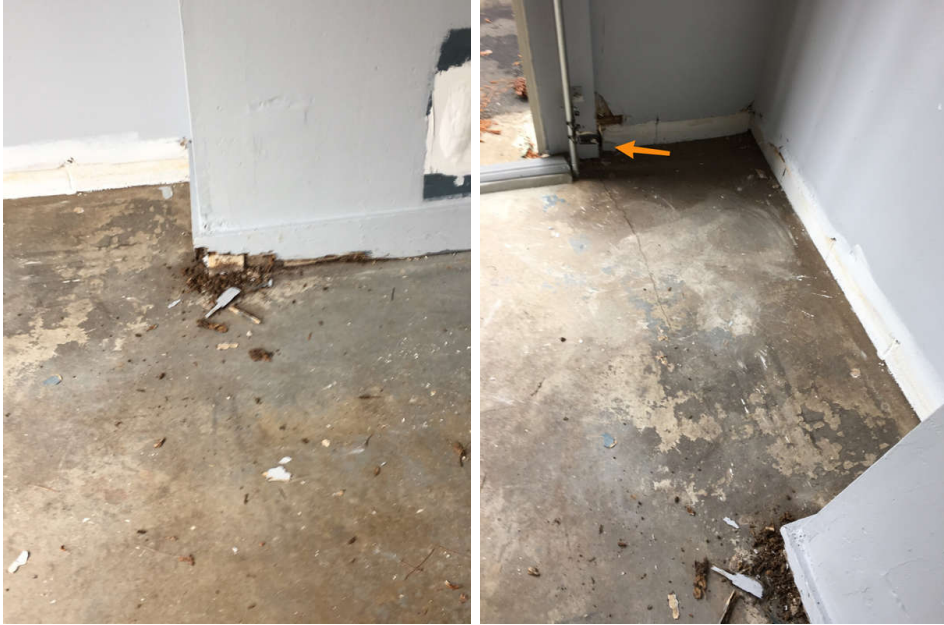
#### 10.4.2 Walls

### **MOISTURE DAMAGE**

Stains on the walls visible at the time of the inspection appeared to be the result of moisture intrusion. The source of moisture may have been corrected. Recommend further examination by a qualified contractor to provide confirmation.

Contact a qualified professional.

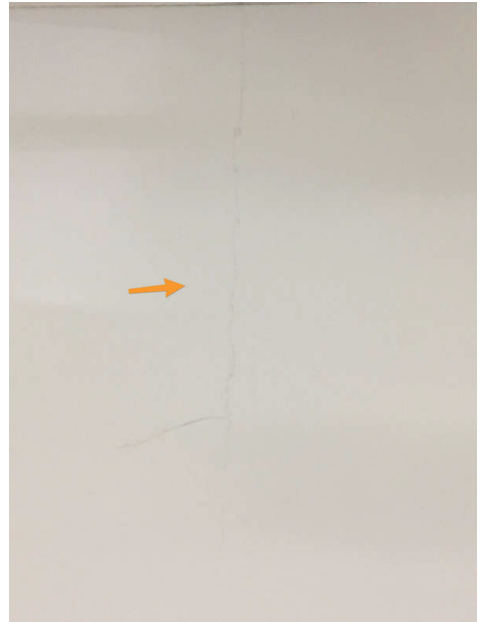
#### 10.4.3 Walls

### **PAINT CRACKING**

Wall paint was cracking in one or more areas. Recommend a qualified painter evaluate and apply a new coat.

Contact a qualified painter.

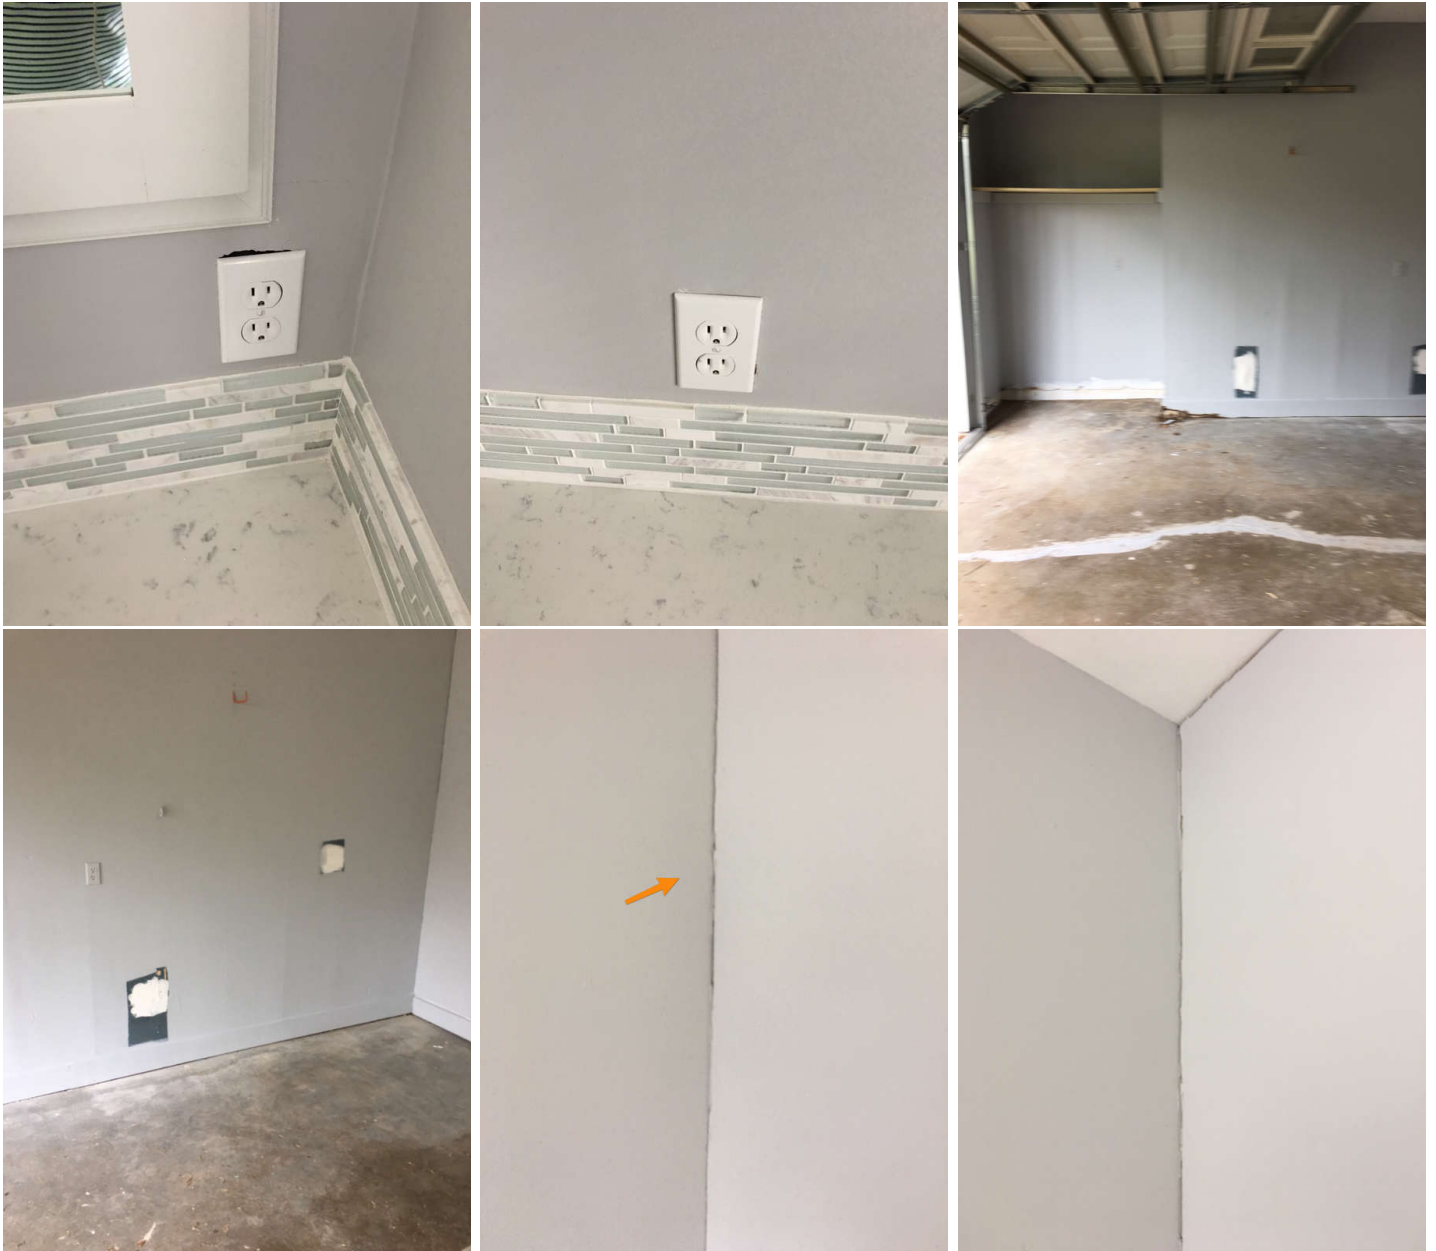
#### 10.4.4 Walls

### **POOR PATCHING**

Sub-standard drywall patching observed at time of inspection. Recommend re-patching.

Contact a qualified drywall contractor.

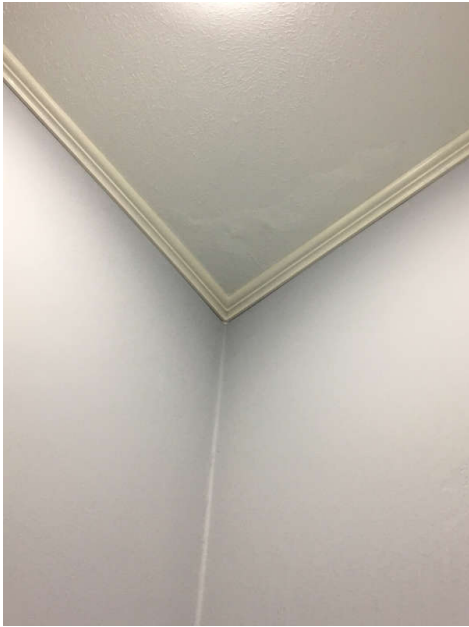
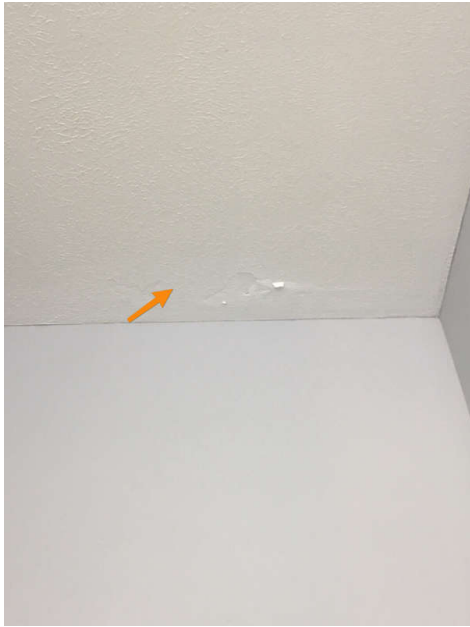
#### 10.5.1 Ceilings

### **RECENT ROOF LEAK DAMAGE**

Stains on the ceiling appear to be the result of roof leaks. The source of leakage should be identified and corrected, and the ceiling re-painted.

Contact a qualified professional.
